# BOSTON REGION METROPOLITAN PLANNING ORGANIZATION

## MEMORANDUM

**DATE:** December 19, 2013  
**TO:** MassDOT Highway Division District 3  
Town of Milford  
**FROM:** Chen-Yuan Wang  
Boston Region Metropolitan Planning Organization Staff  
**RE:** Community Transportation Technical Assistance Program—Town of Milford

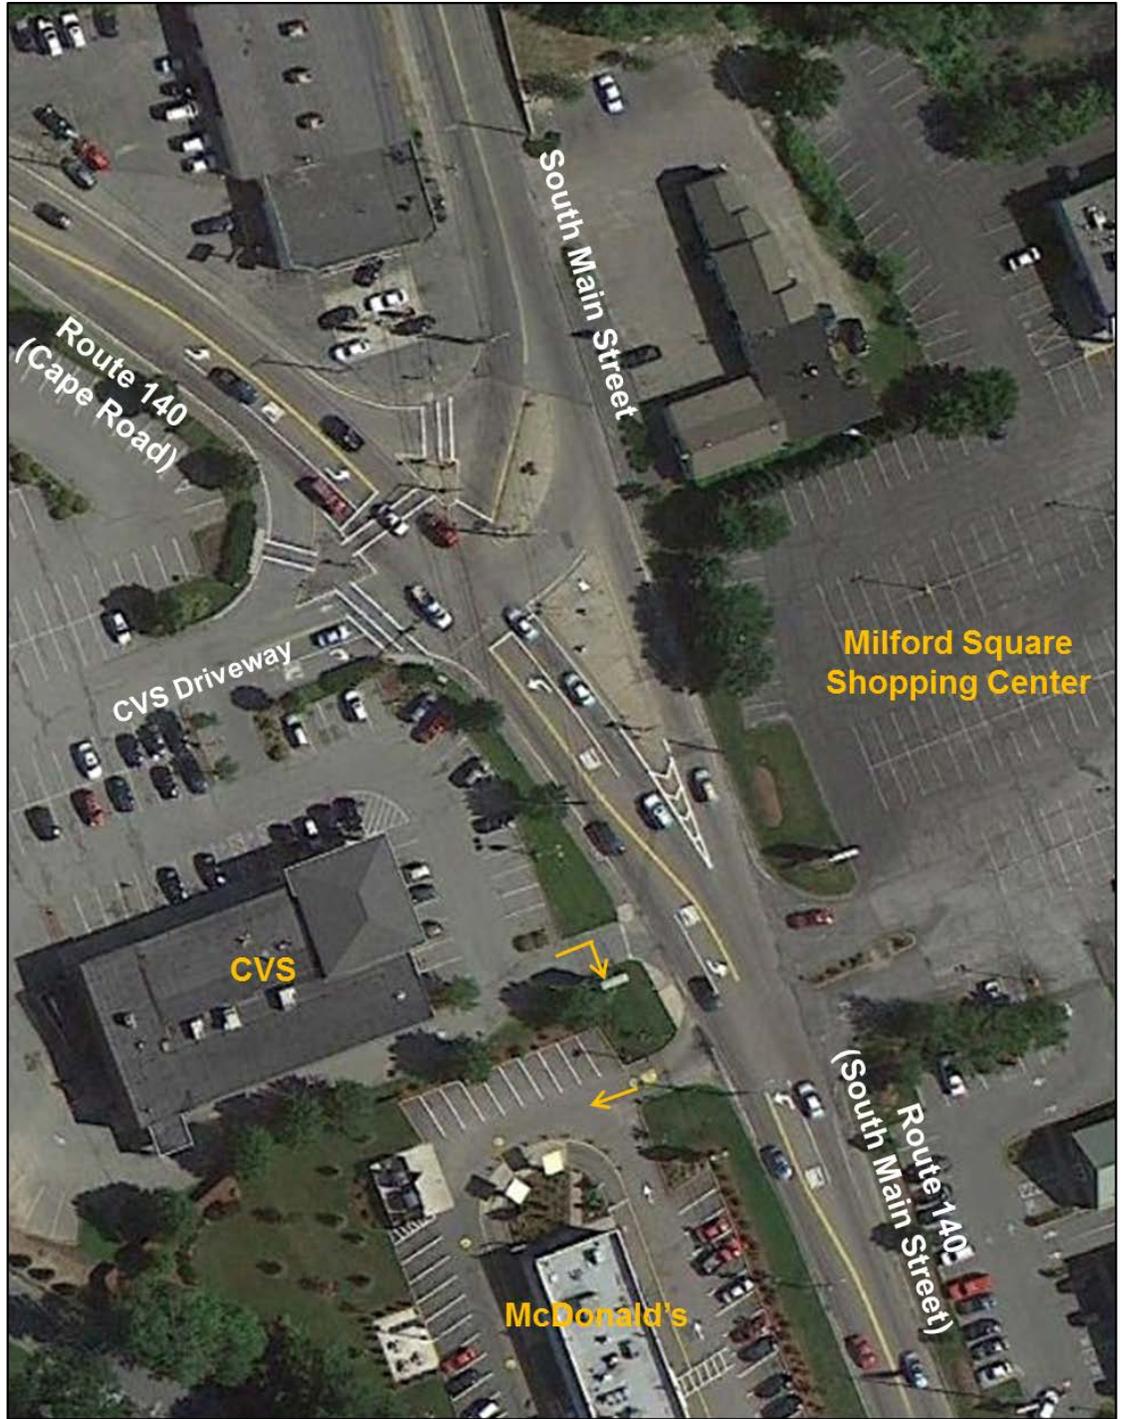
**FIGURE 1**  
**Existing Intersection Layout and Adjacent Developments**  
**Route 140 at South Main Street, Milford**

As shown in Figure 1, Route 140 is a two-lane principal arterial. The northwest-bound approach to the intersection (South Main Street) is divided by a long triangular traffic island. The right lane continues as South Main Street and is controlled by a pair of yield signs, not within the control of the intersection's traffic signal. The regular-sized yield signs are not obvious from a distance at this wide approach. The left lane connects to Cape Road at the intersection and is widened to include a left-turn bay that accesses the adjacent CVS/Papa Gino's (Figure 2).

- Increase the size of the two South Main Street northbound yield signs (see Figure 1) to 48”x48”x48”

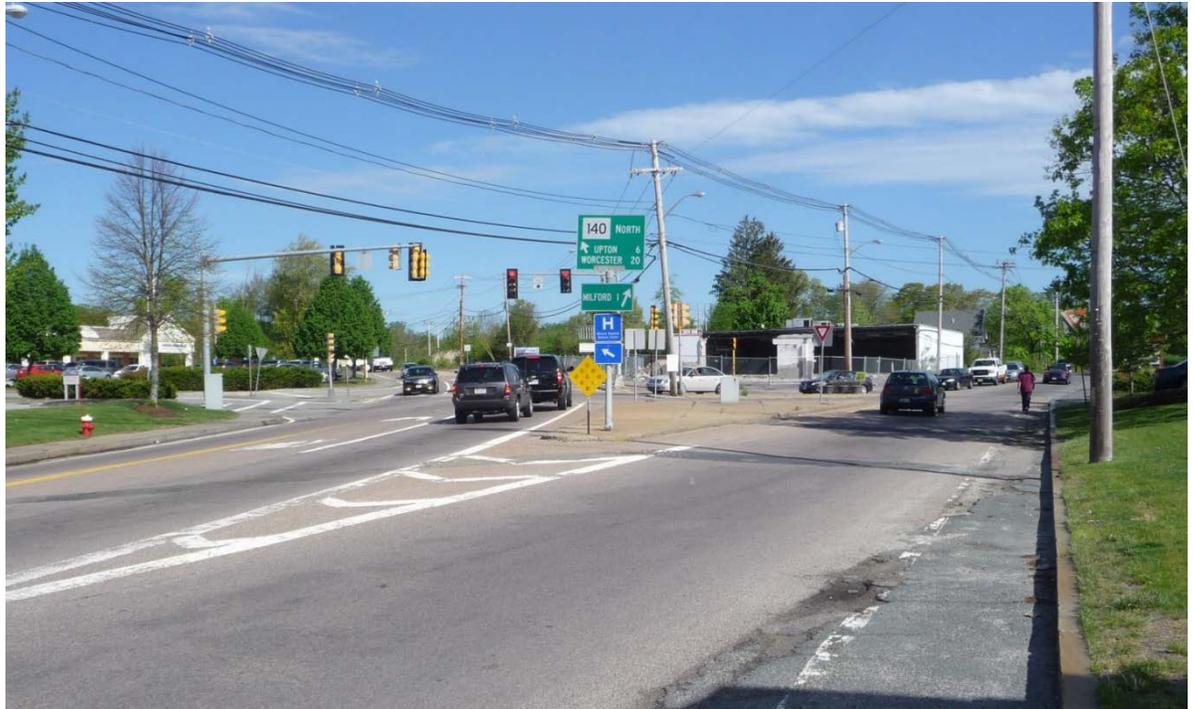
**FIGURE 2**  
**South Main Street Northbound Approach**

The through movement from the CVS driveway aligns better on the right than on the left lane to South Main Street northbound (see Figure 2). The proposed lane reassignment would require pavement restriping and a few changes:

<sup>10</sup> The right-turn lane appears to be wide (20 feet or more) and the islands can be expanded somewhat, especially the one at the CVS driveway. Currently there is a do-not-enter sign facing the driveway at the turnoff (see Figure 2). A narrower opening with an appropriate division island design and pavement striping would reduce confusion.

- Restripe the right lane with a through/right-turn arrow and the left lane with a left-turn-only arrow
- Change the two existing right-lane-must-turn-right signs to read “left lane must turn left”
- Mark “to South Main Street” on the right-lane pavement and “to Cape Road” on the left-lane pavement<sup>5</sup>

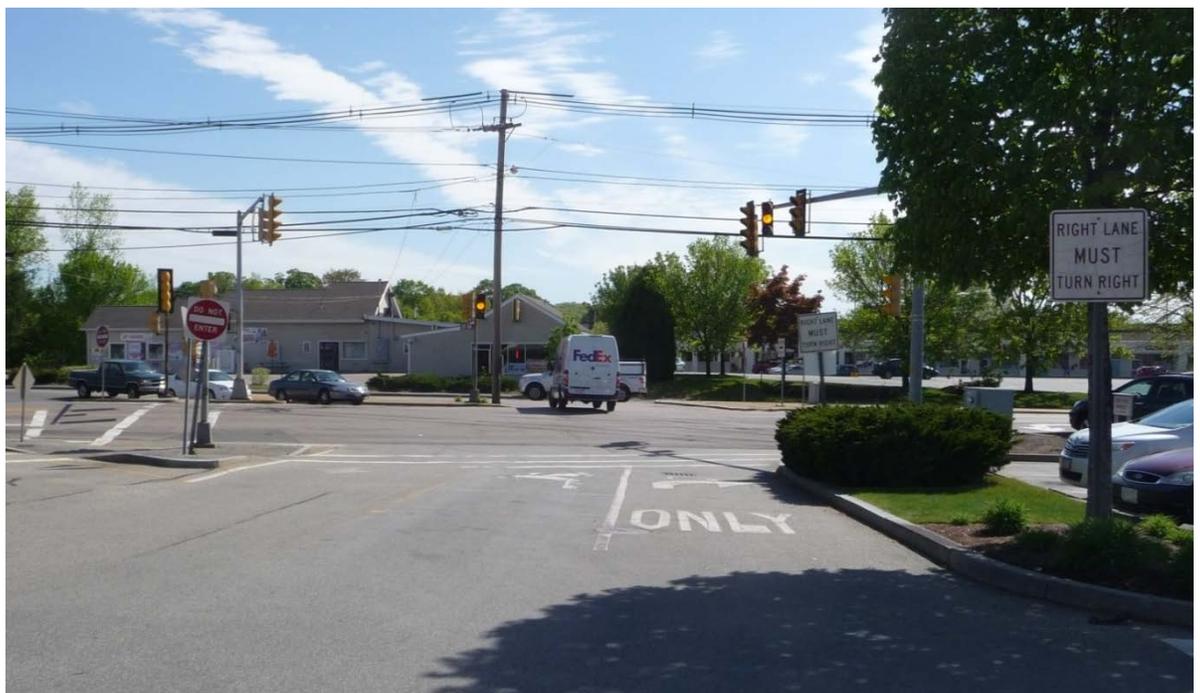
**FIGURE 3**  
**CVS Driveway at the Intersection of Route 140 and South Main Street**

The Route 140 southeast-bound approach (Cape Road) also has a single lane. At the intersection, it widens to include a left-turn bay that accesses South Main Street northbound and a short channelized right-turn lane, which accesses CVS/Papa Gino's. South Main Street, also classified as a principal arterial, has one lane approaching the intersection from the north. It is mainly used as a through- and left-turn shared lane with a very short right-turn channelized turnoff. The CVS driveway contains two 10-foot lanes: one for through- and left-turn movements and the other for right turns only (Figure 3).

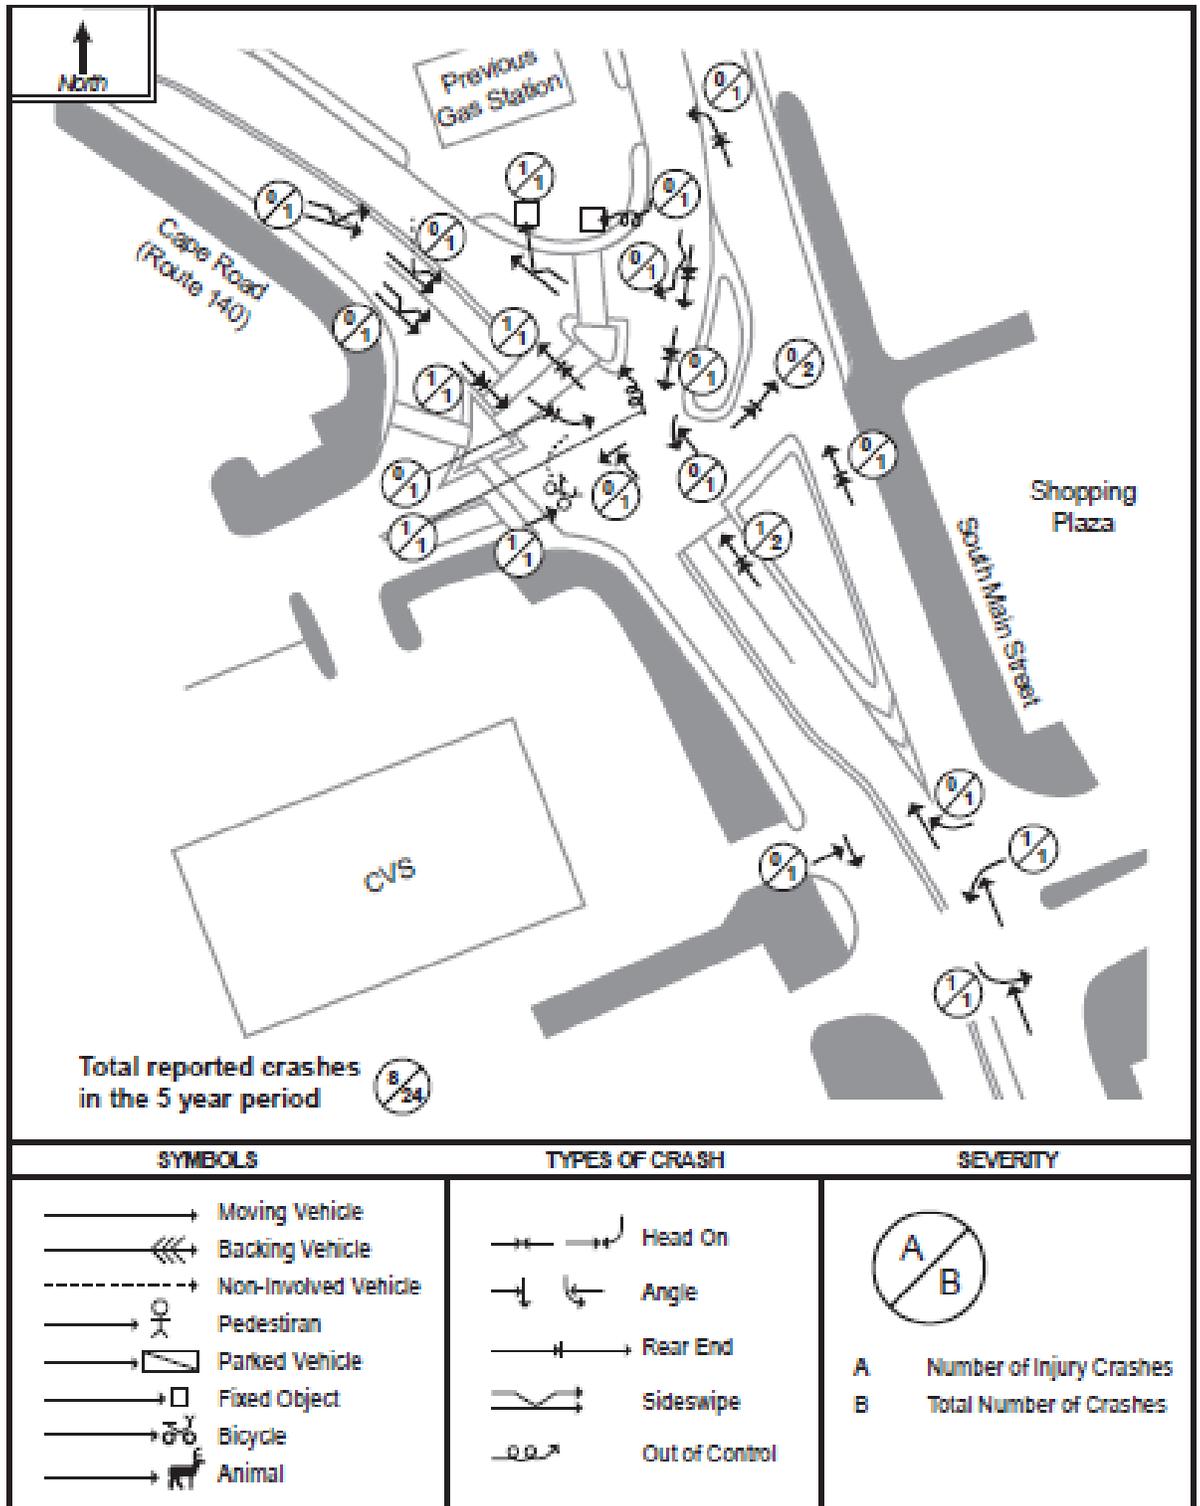
**FIGURE 4**  
**Intersection Collision Diagram**  
**Milford Police Crash Reports 2008–12**

Based on the Milford Police Department crash reports, MPO staff constructed a collision diagram for the intersection (see Figure 4). The diagram shows a range of different types of collisions occurring at different locations, with no noticeable crash patterns. The most problematic location, the yield sign northbound on South Main Street, does not have a high number of crashes. In the five-year data shown in Table 1, three rear-end crashes (with no personal injuries) were related to an approaching vehicle failing to yield or stopping too late.
